Diagnostics: Emissions Fault

When an older model Mercedes failed the MOT test on excessive emissions, the resulting trouble code proved less than straightforward in its attempt to explain the cause of the fault.

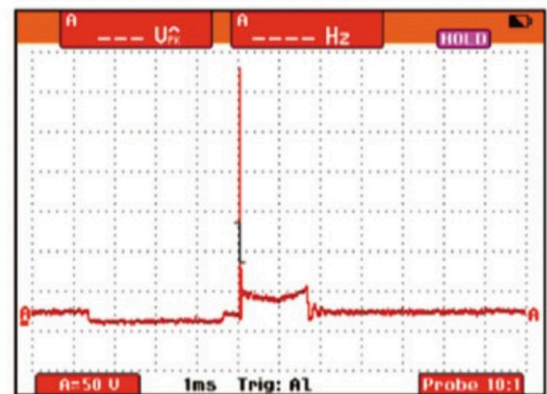
As you can see in Fig 1, there was a textbook primary wave pattern on two of the coils. Just prior to the firing line you can see the current limiting hump, indicating that the coil had become fully charged, and that the engine ECM had stopped charging this particular coil.

Fig 1: Two of the coils in the Mercedes were perfect, as can be seen in this textbook coil primary trace.

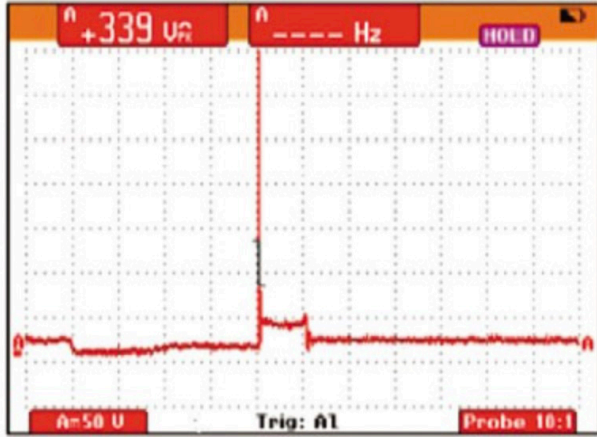
In Fig 2, the circumstances are far different. You can see straight away that there is no current limiting hump; in fact, 2ms into the coil charging time, the engine ECM stopped charging this coil, or what was more likely happening was that the insulation on this coil was breaking down.

Fig 2: One of the coils in the Mercedes was obviously faulty – the result of a short to earth through the coil insulation.

The breakdown of the coil insulation created an earth path, and prevented this one coil from charging properly. Also note that the burn time was only half the time of the other two coils, and that there are no coil oscillations, therefore indicating a discharged coil. The faulty coil was replaced, the code was cleared and the emissions returned to normal.
