## Gates: Vauxhall Astra 1.6 Sensor Fault

Andy Horwat, of Engine Tuning & Diagnostics in Swindon, investigates a cam **sensor fault on a Vauxhall Astra 1.6, 56 plate.**

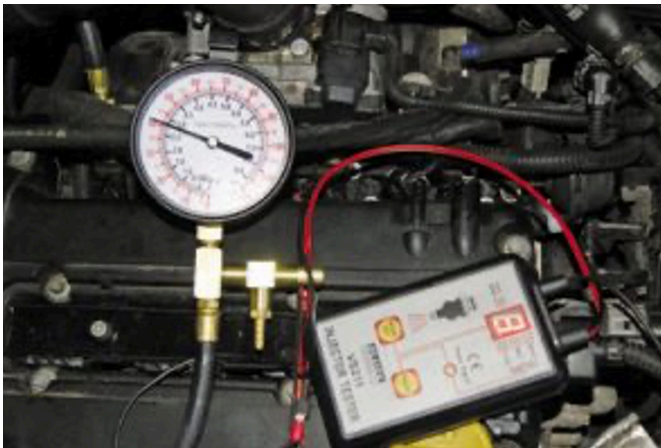
The symptoms I discovered included a severe lack of power and hesitation and the garage owner (who was also an ex-Vauxhall mechanic) pointed out that the sensors were 'aftermarket' parts which were found to be incorrect.
