Engine Parts & Timing Belts: Overlap of the Backplate Prong

A motor factor's report suggested that a tensioner bolt had 'sheared' and caused major engine damage, the Gates Inspector was invited to assess the situation. The engine in this case features one main belt drive and one secondary smaller belt drive.

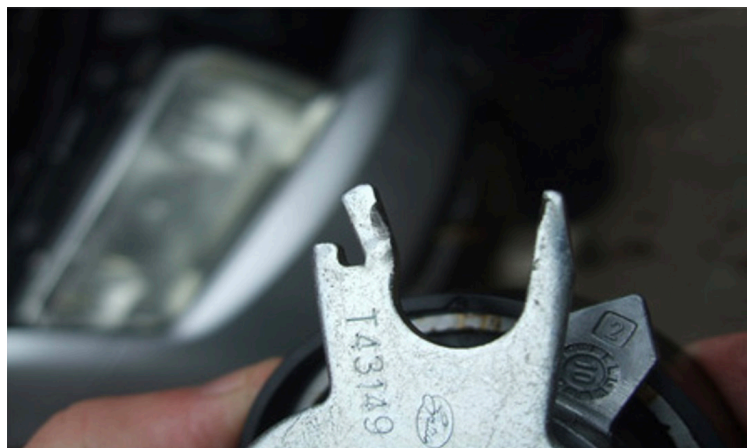
Here we see overlap of the backplate prong

Here we can see unusual wear on the prong

The backplate on this model resembles a twopronged fork. These sit on either side of the 10mm bolt. Close examination of the backplate showed that it was bent forward and had suffered from some kind of abrasive action. The marks – apparently caused by wear – were unusual. The sheared bolt was removed and a replacement was sourced in order to make a comparison. The damaged tensioner was also offered up to the engine. A reconstruction of the installation procedure indicated that it was possible to mount the backplate of the tensioner incorrectly, even though the pointer was in the correct position. Moreover, the marks on the backplate could be reproduced if one of the prongs was seated on top of the bolt.

In such a position, under load, the tensioner would malfunction and cause the cursor to come into contact with the end stop. As a consequence, the backplate would rotate and this movement would drop the incorrectly-seated prong into the correct position, to the side of the bolt. However, by this stage, the damage had already been done.

Failures like those listed usually take place at some time after a scheduled belt replacement procedure. As in this case, they are more likely to be the result of installation error. The correct torque must always be applied, however, no amount of torque can compensate for an incorrectly located backplate. That's why it's imperative that you always check the position of the backplate after installation.
