# Hella: Air Conditioning No Longer Operates After Eliminating Leakage or Following Air Conditioning Service

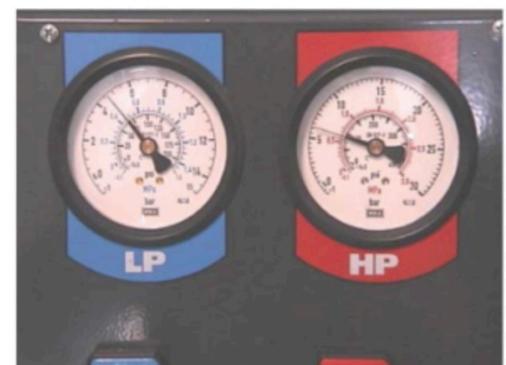
Figure 2

When the air conditioning is put back into operation, it is possible that the compressor no longer has any output. If the pressure values indicated in the service station are considered, it is noticeable that the values on the high and low pressure sides are virtually identical

(**Figure 2**). This allows the suspicion that the flow through the refrigerant circuit is insufficient, e.g. at the expansion valve, or that the compressor is defective.

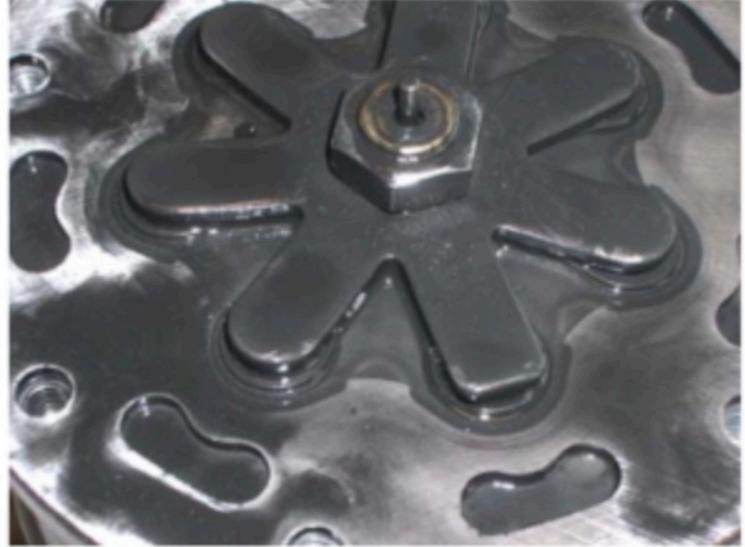
Figure 5

If problems arise, the compressor should be removed and the oil drained. If the oil has a “grey discoloration” (when contrast agent is used (grey-green or grey-yellow) resulting from fine metal particles (Figure 5), it is necessary to properly flush the refrigerant circuit due to the foreign particles, replace the expansion valve and filter/drier and evacuate the refrigerant circuit again in conformance with specifications and recharge the system with refrigerant and oil. The system should then operate properly.
