REXPERT: Vauxhall Movano 2.3D

Alistair Mason replaced the clutch on a Vauxhall Movano 2.3D, which has covered more than 140,000 miles.

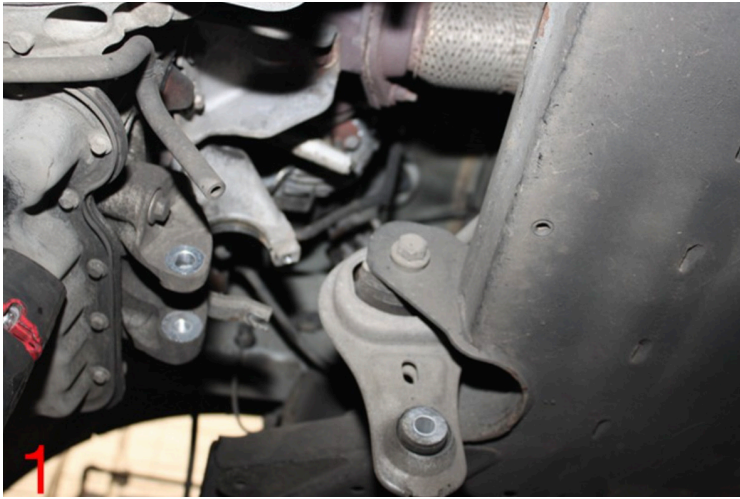
Next, raise the vehicle further and drain the gearbox oil into a suitable receptacle, then refit and tighten the drain plug and remove the centre tie bar (Fig 1).

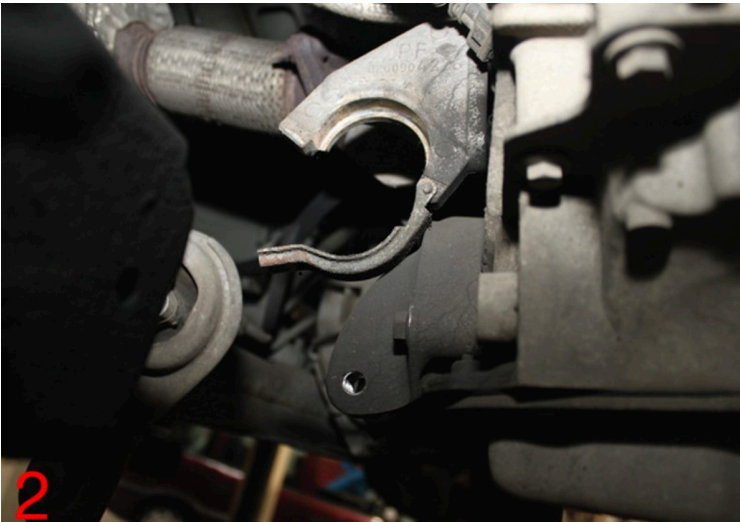
Swing the engine forward to improve access. Remove the RH driveshaft centre bearing clamp (Fig 2) and both drive shafts, then unclip and disconnect the cable on the rear of the gearbox support bracket. Unbolt the rear bell housing bolts and unclip the drain hose.

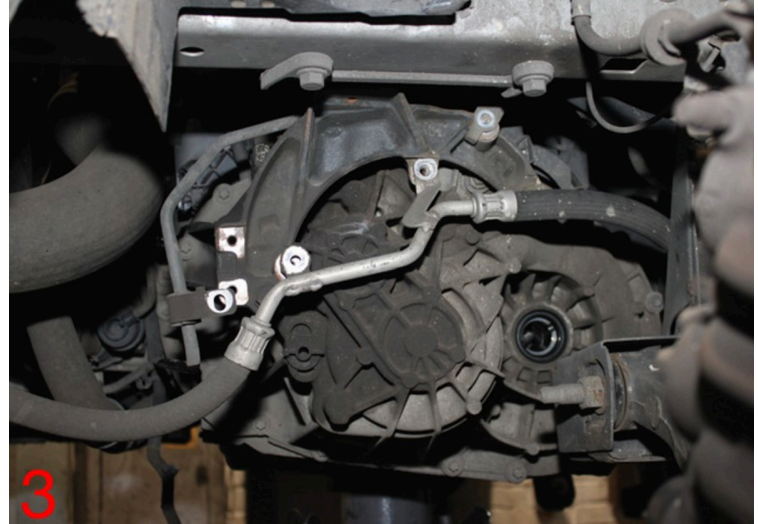
With the engine supported from above, remove one of the gearbox support bracket bolts and lower the gearbox and engine slightly. Unbolt and remove any pipes attached to the gearbox mount (Fig 3).

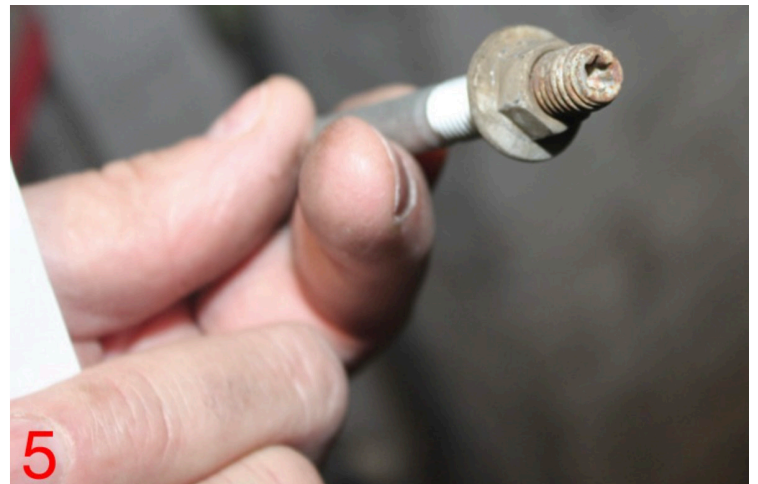
Remove the starter motor bolts and the rest of the bell housing, leaving the two nuts on special studs at the top (Fig 5).

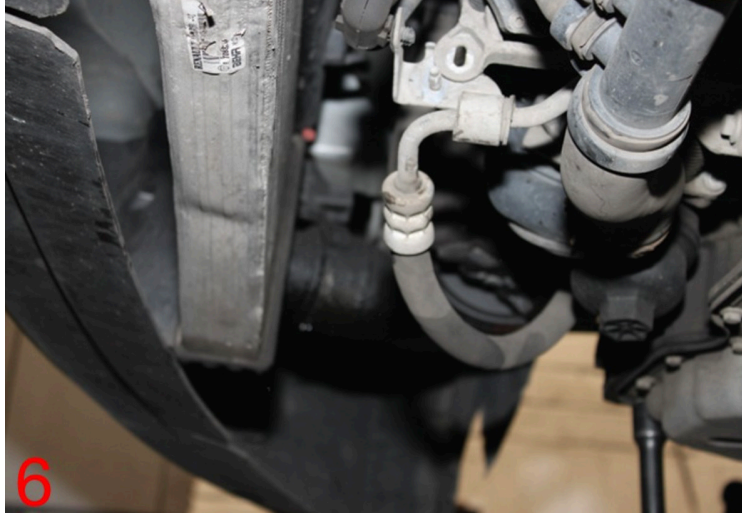
Release the A/C hose front bracket (Fig 6) to allow the pipe to be moved further out of the way. Support the gearbox with a transmission jack and remove the gearbox mounting bracket (Fig 7), then the remaining bell housing nuts and the special studs.

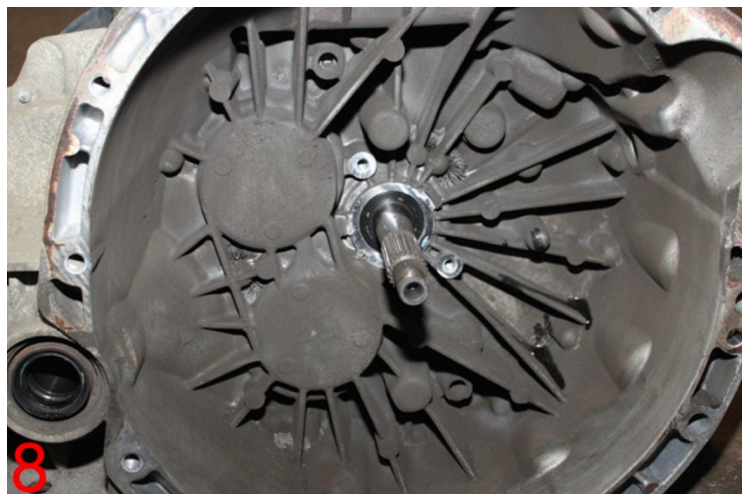
Unclip the concentric slave cylinder (CSC) extension pipe, which may be useful for a future blanking plug. Unbolt and remove the CSC, carefully noting the gearbox seal (Fig 8) condition.

Refit the new CSC, taking care not to compress it prior to fitment. Make sure to use the original or new and correct bolts – don't be tempted to replace them with something 'similar'! Once completed, fit the new extension pipe, making sure the clips locate correctly.
