GATES: Installation of the fan clutch assembly

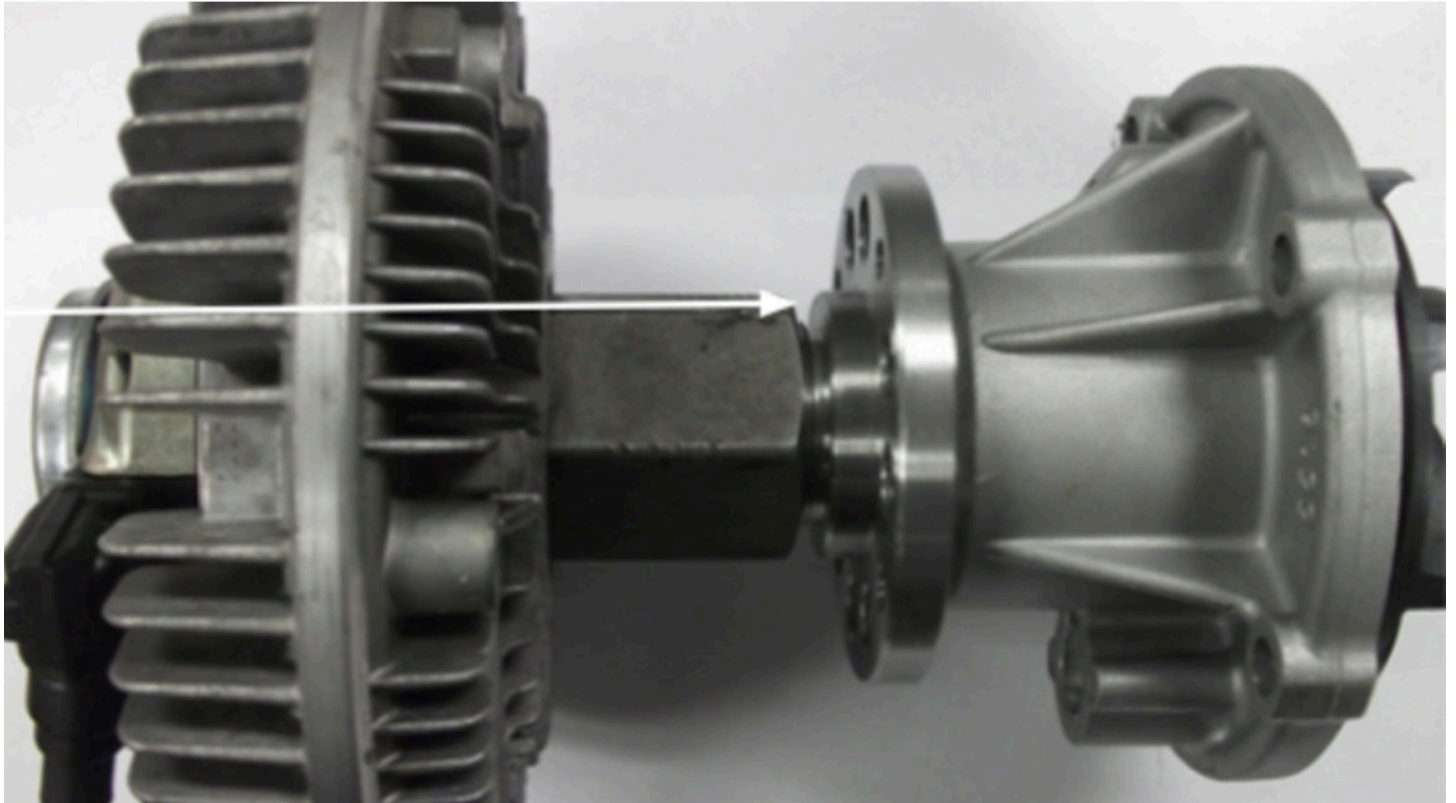
Upon installation of the fan clutch assembly, be certain to completely secure the clutch nut until flush with the water pump flange. Failure to secure and properly torque the fan and clutch assembly to the water pump, may lead to premature water pump failure and or an unsafe operating condition.

The Gates Technical Team has found through extensive field analysis, the fan clutch assembly is not being secured into position correctly at the time of installation, but allowing the direction of engine rotation to tighten the fan assembly in some cases. This process **does not** provide appropriate attachment torque for operation, as the rotating mass of the fan may loosen the clutch nut upon shut-down.

Note: OE Recommended Torque Specification Is: (98 Ft. Lbs. or 133 N.m). The clutch nut is manufactured with right handed threads and will need to be rotated counterclockwise for removal.

A loose fan clutch assembly will create an imbalance within the fan to water pump. This imbalance creates excessive force upon the water pump shaft and bearing which can lead to a bearing walk out condition. This premature failure due to improper installation may affect other nearby components resulting in excessive repair costs.

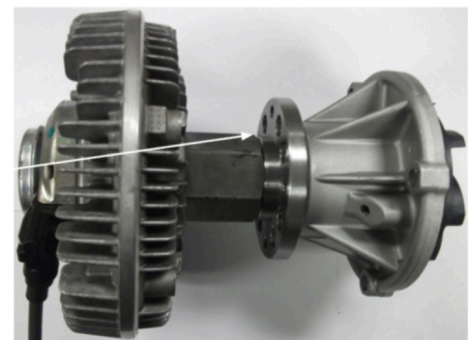
Fan clutch and water pump need to be seated & torqued to 98 Ft. Lbs/133 N.m before engine is started.

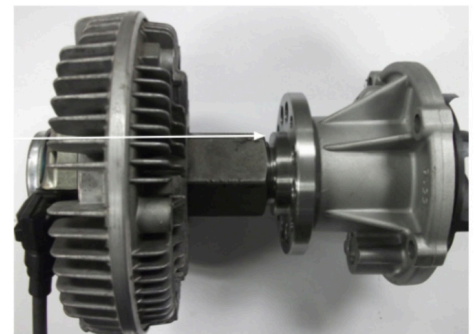
Improper installation between fan clutch and water pump.

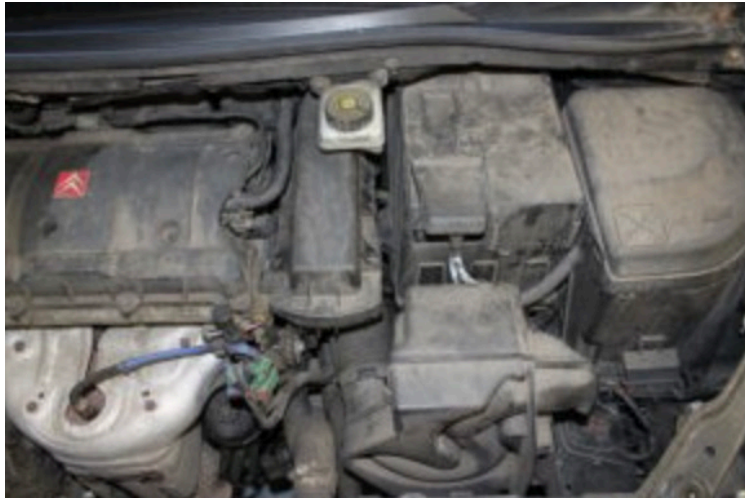
Remove the battery

Detach the battery retaining clamp and then remove the battery. The bolt holding the battery housing in place is only accessible from behind the n/s wheel arch liner. Raise the vehicle and remove the n/s/f wheel. You can now release the hub nut by removing the "R" clip, nut retainer and finally the hub nut.

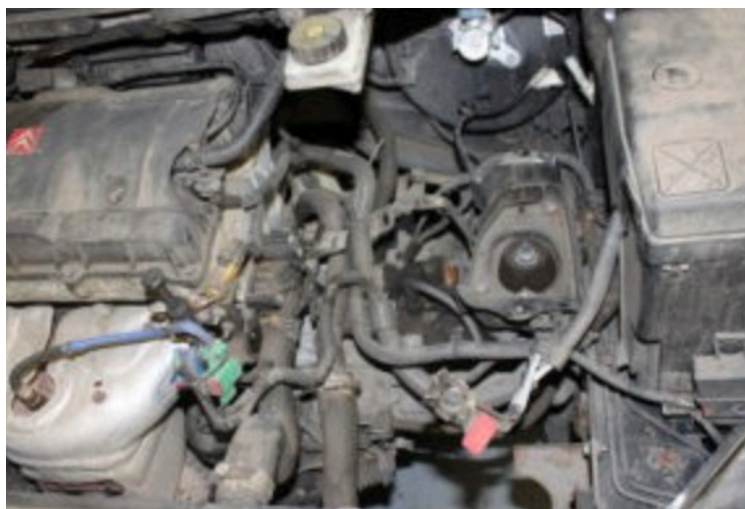
This now gives good access to the gearbox. Disconnect the reverse light switch and earth cable, remove the two bolts for the clutch slave cylinder, unclip the hydraulic pipe from the support bracket and stow away from the gearbox.

Release the gear linkage from the gearbox (you can also remove the gear change pivot weight to aid removal). Whilst in this area, there are two bolts that can be removed – one for the starter motor and one for the gear linkage bracket on the outside of the bell housing.

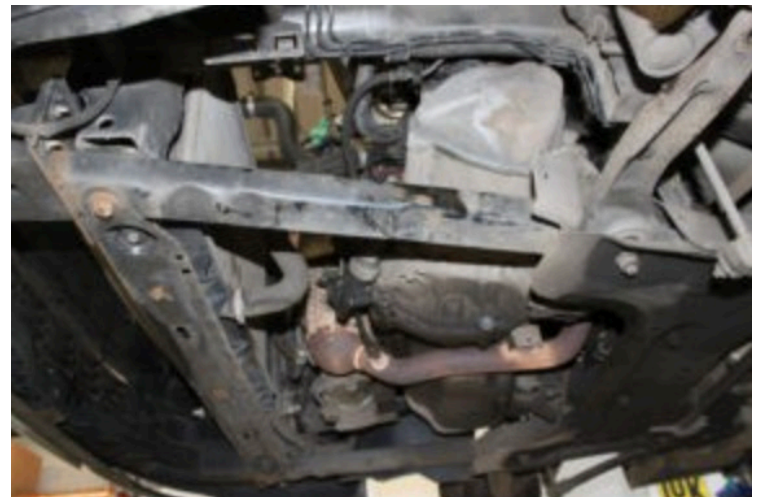
Remove the two retaining bolts that hold the gear linkage bracket to the gearbox and also remove the two starter motor bolts. Now remove the n/s sub-frame bar (see below) by removing the front plastic under tray, removing the two bolts in the front corner of the bar and the four bumper bracket retaining bolts and then detaching it from its location points at the rear of the bar.

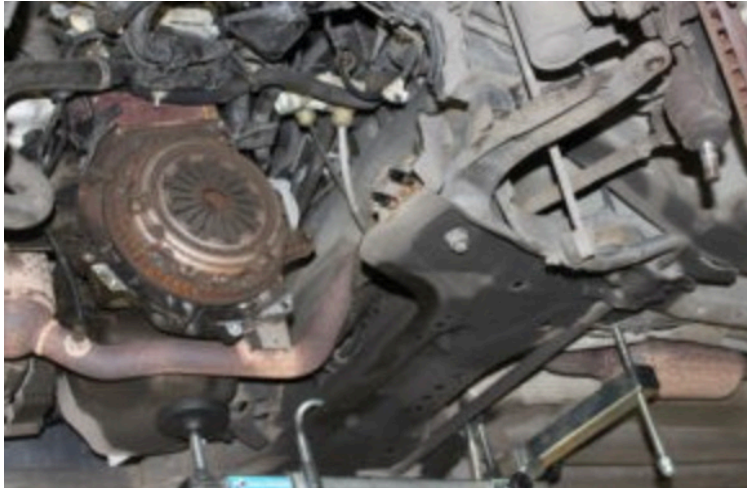
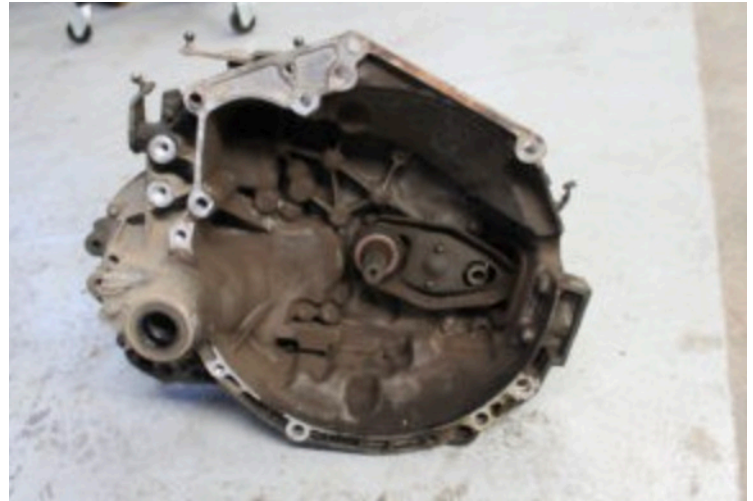
Lower the gearbox and engine so the gearbox mounting clears the gearbox studs. Then remove the final two bell housing bolts, ease the gearbox back until free and then lower the transmission jack to remove the gearbox (see below). Remove the clutch assembly (when inspecting the clutch plate wear was evident, indicating the clutch plate was near the end of its service life), clean and inspect the flywheel and remove the glaze with some emery cloth.

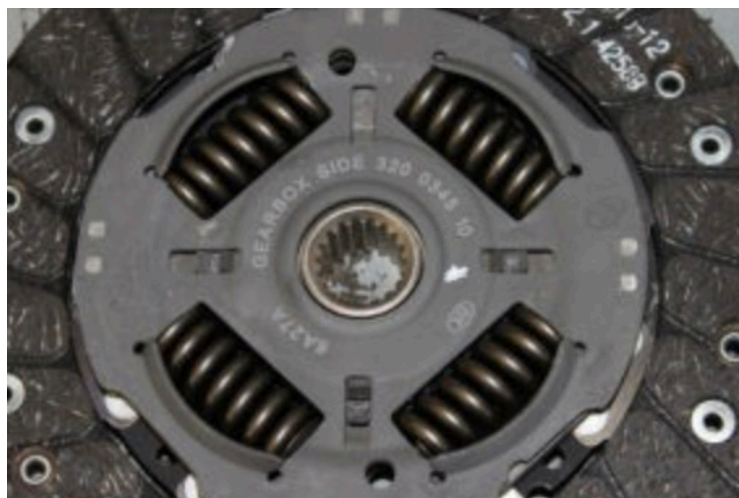
Fit the new clutch assembly to the flywheel using the correct clutch alignment tool – the clutch plate is also marked “Gearbox side” or “Getriebe seite“ to aid installation (see below). Now torque the clutch bolts to the manufacturer’s specification before reinstalling the gearbox and torquing the bell housing bolts. At this point you should feel the release fork for a small amount of free play to ensure correct installation.
