Diagnostics: Suzuki Vitara

Josh Jones had his hands full with an old-school Suzuki Vitar. Here, he recalls how refreshing it was to work 'scan tool-free' and go back to basics.

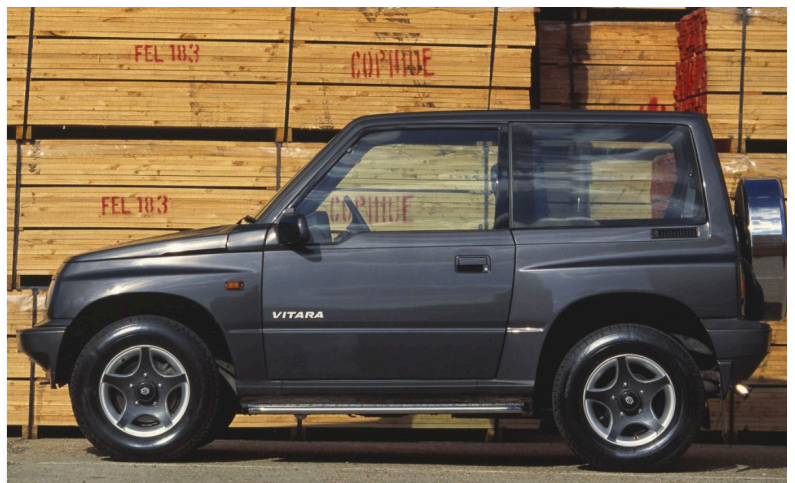
Believe it or not, the engine was fitted with single point injection and with the injector harness itself being clear to see and test, I decided the easiest starting point would be to check voltages to establish if the engine ECM was at least powering up, I also wanted to check if the engine's rotation was being picked up correctly by the crank sensor, and thus initiating fuelling and ignition. The injector was easy to separate as there were simply two wires emerging from the centre of the throttle housing and they were linked to the main wiring loom via a connector. I connected here with a power probe to check operation on cranking, but got absolutely nothing – no ignition supply or switching signal on either wire. Was the ECM even powering up? Upon cycling the ignition switch, I listened for a fuel pump prime and could hear one for definite. In light of this, I was sure the control unit was at least coming to life when the key was turned on.

To check if the spark ignition side of things was operational, I carried out a simple test using the same two wires, in order to save time. With the fuel injector disconnected at the aforementioned plug, I manually activated it with the power probe for a very short period. The injector could be heard to click and the holding pressure in the fuel system from previous ignition cycles delivered a very small amount of fuel into the inlet manifold. I then simply cranked the engine, which straight away coughed into life – briefly – before obviously dying again. I was confident I was looking at a lack of fuel injection as the cause of the non-start condition.

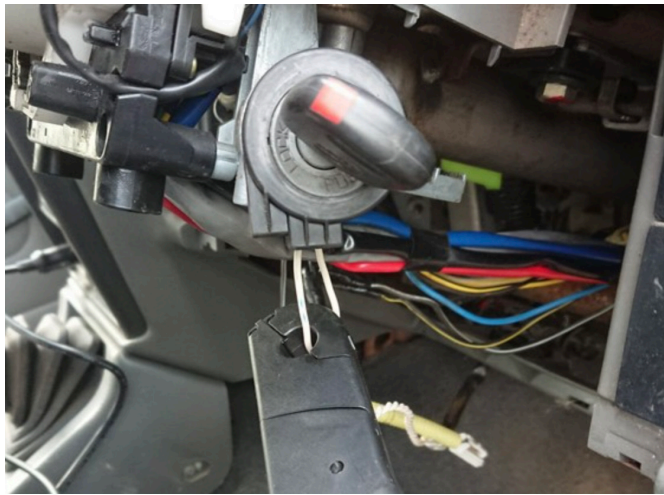
got a bit strange for a moment. With the ignition switch turned off and with the injector disconnected at the same multi- plug, I carried out a continuity test from the injector control terminal on the ECU side of the plug and battery negative, simply to check whether or not there was an open circuit. When the ignition was turned on, the test showed an open circuit. When the ignition was turned back off, about five seconds would elapse before the ground path would return, presumably via the ECM. It was at this point that a little nagging thought from earlier came back into my head. Up until this point, I had not paid much attention to the fact that there had been no sign of a 'check engine' warning lamp displayed, even in a 'key on, engine off mode', which is why I needed to use the fuel pump prime as a rudimentary way of confirming ECM power up.

On a newer model, no EML would have rung alarm bells straight away, but as this vehicle was pre EOBD, I simply did not pay enough attention to the missing lamp. Upon closer inspection of the instrument cluster, I found that there was a poor connection on the PCB. This turned out to be the 'check engine' lamp, which was trying its best to frantically flash at me every time the key was turned on, but could not due to the loose bulb. A check of the owner's manual (which was still present, amazingly) confirmed my suspicion – a flashing lamp was a warning that the key transponder was not recognised!

After this discovery, I wanted to confirm that it was indeed the key transponder itself at fault and not any wiring or immobiliser module issues, as this could have potentially made the vehicle uneconomical to repair. I used my amps probe (see above) to connect to the receiver ring circuit of the immobiliser. When the key was cycled to the ignition position, the immobiliser control unit attempted to probe for a response from the key chip before giving up.

After a call to my friendly local locksmith, it was confirmed that a new transponder was very easy to program. After his visit, I checked to see that – with the current probe – the key was once again responding correctly. You could clearly see a difference – only one 'pulse' was needed to communicate before the chip was energised to respond. The rhino was ready to roam the plains once more. Lesson learned!
