LuK: Full replacement guide for the C180 1.8 Petrol, 2003

1.8 Supercharged 2003 model, which had covered over 140,000 miles and the customer had noticed a little clutch slip

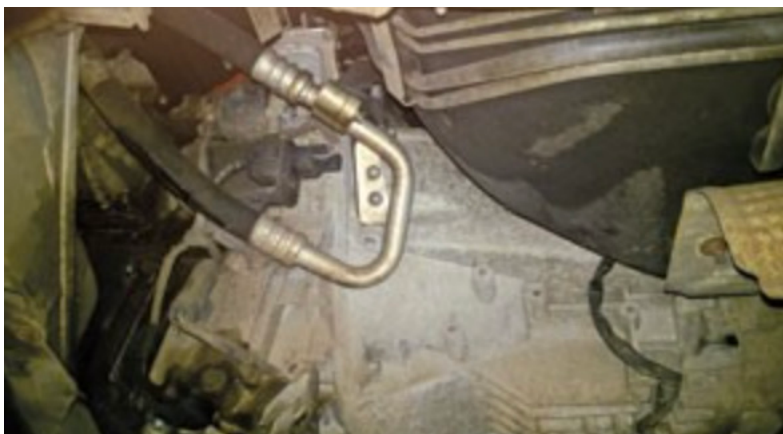
For this repair, the workshop equipment we advise is a two-post ramp and a transmission jack. With the vehicle placed on the ramp, it is recommended that you disconnect the negative battery lead for safety. There is no work to be carried out from the top side of the vehicle, so raise the ramp and remove the engine and gearbox under shields. Disconnect the PAS pipe from the gearbox bell housing by removing the two TRX bolts.

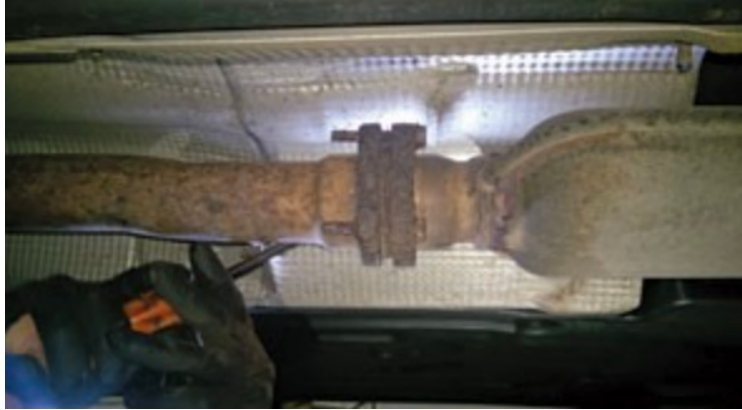
Exhaust centre removal

Disconnect the gearbox speed sensor multiplug located on the underside of the gearbox before disconnecting the reverse light switch multiplug at the rear of the gearbox. You should then remove the gearbox earth strap and now disconnect and completely remove the exhaust oxygen sensor.

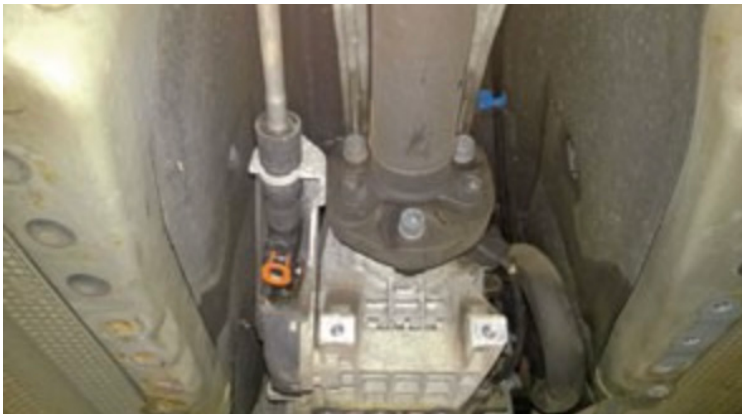
Disconnect the exhaust centre joint by removing the three bolts (these may be corroded) and then remove the exhaust front pipe support bracket. Now remove the rear gearbox mounting, before disconnecting the prop-shaft from the gearbox.

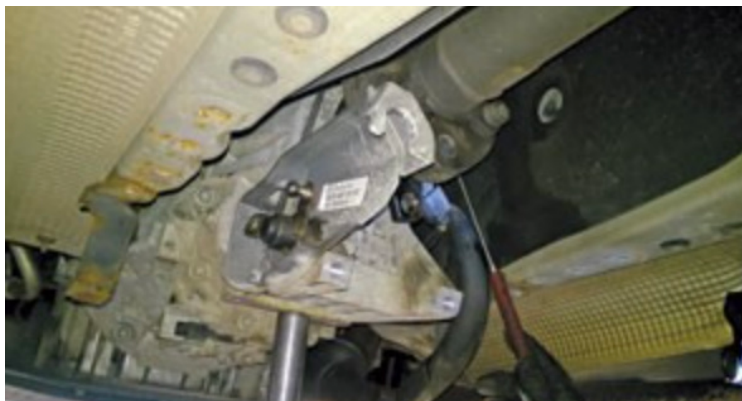
Remove the rubber cushion drive unit, noting the position and colour of the bolts and washers as they have different locations. Now disconnect the hydraulic clutch pipe; the easiest point for this is where the hydraulic pipe comes through the transmission tunnel on the O/S. Once disconnected, the pipe connection needs to be blanked to prevent the fluid leaking out.

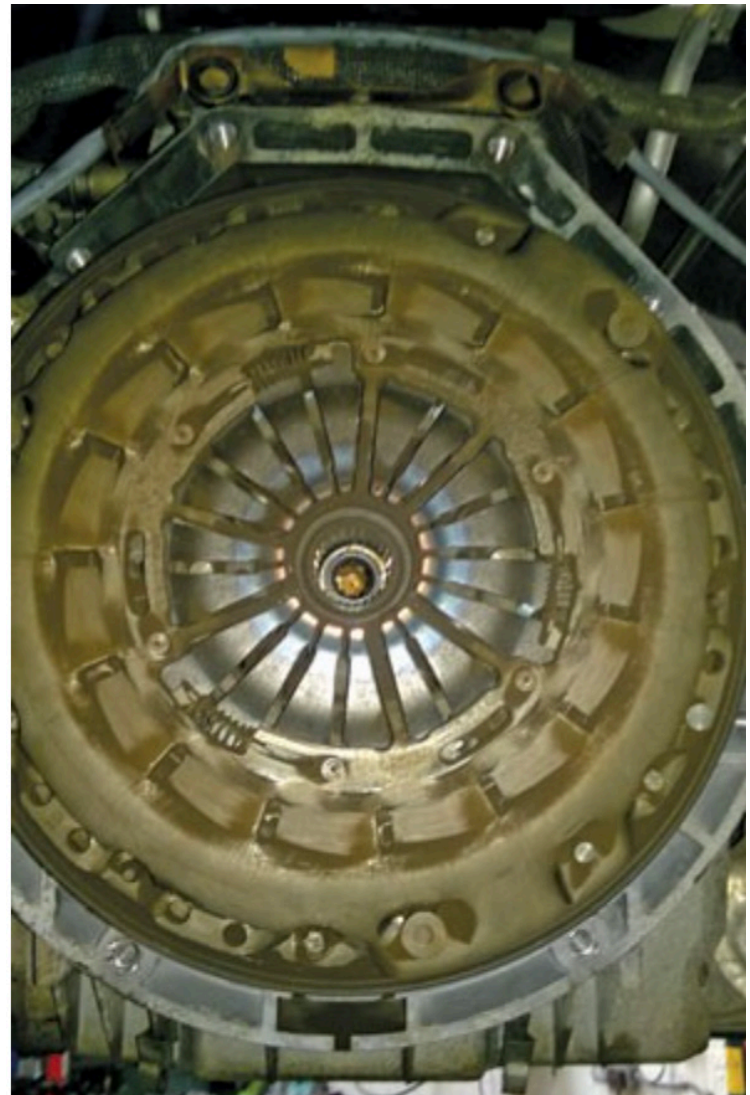
End Limit

With the gearbox removed, an initial inspection showed the clutch was at its end limit as the three little adjustor ring springs were fully extended. Remove the clutch assembly and test the dual mass flywheel (DMF) for play and rock – this information is available through Schaeffler's Repxpert website, on-line catalogue and/or DMF Checkpoint App.

Remove the Concentric Slave Cylinder (CSC) from the bell housing, clean the bell housing and fit the new CSC. Clean the flywheel face to remove the "glaze"; for this we used an Emory cloth. It is now good practice to try the new clutch plate on the gearbox input shaft to ensure the splines are correct and to lubricate the clutch splines with a small amount of high melting point grease so we have an even smear and any excess is wiped off. Fit the new clutch assembly using the correct Clutch Alignment Tool and checking the clutch plate is the correct way round showing 'Getriebe Seite' (Gearbox Side) on the outer face – we advise installing the clutch assembly with a Self Adjusting Clutch (SAC) fitting tool.
