## LuK: Double clutch assembly on a Renault Scenic III

Replacing a double clutch assembly on a Renault Scenic III, fitted with Renault's Efficient Double Clutch (EDC) gearbox; this is fitted to Renault's 1.5 dCi engine.

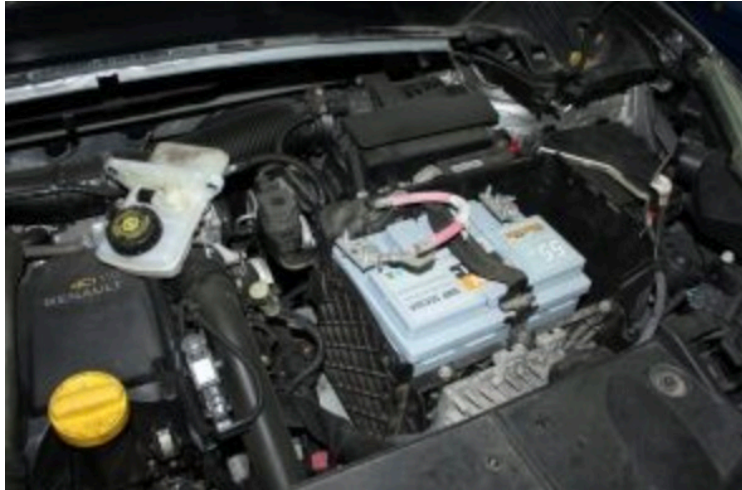
Place the vehicle on the ramp before raising, and then slacken both front driveshaft nuts as these can be very tight and need to be removed during the repair. You should also ensure you have the locking wheel bolt key (if required) and slacken with a bar. Starting in the engine bay, remove the engine cover and then disconnect and remove the battery.

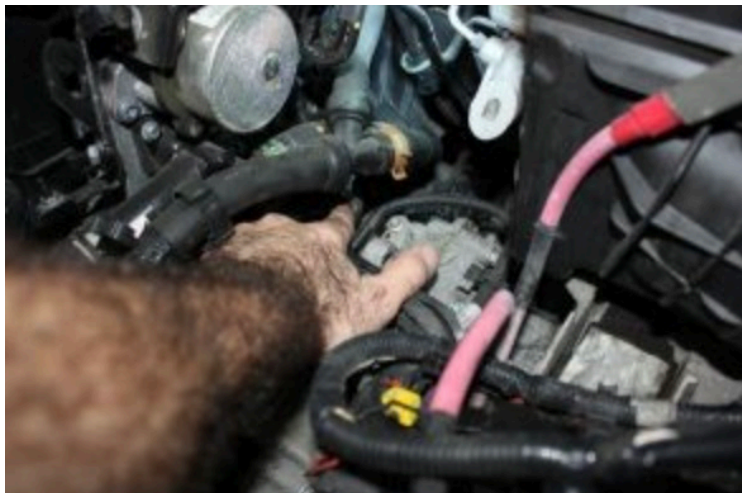
Unclip the battery wiring loom from the gearbox mounting and stow to give greater access to the gearbox area, before removing the gear selector cable from the gearbox by disconnecting the ball joint from the selector mounting ball and disconnecting the cable outer from the gearbox and storing in the bulkhead area.

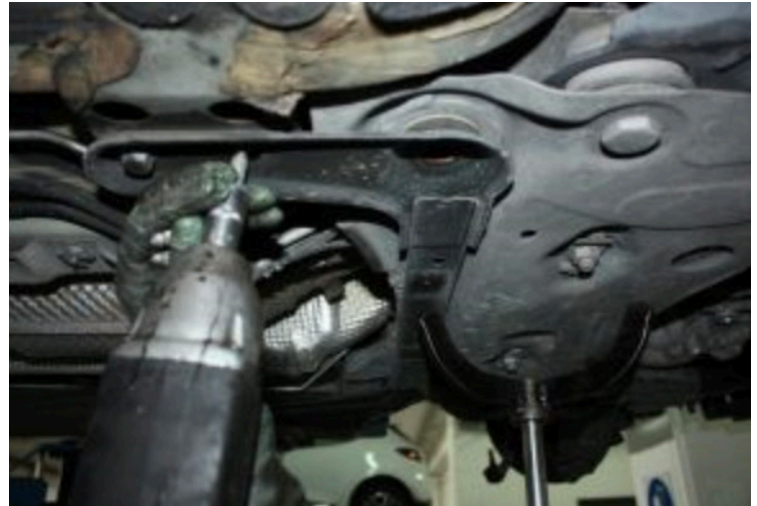
Raise the vehicle to waist height, remove the central part of the front radiator grill and the deflector under the radiator and then the air box assembly. Now remove both front wheels, the engine under tray and the left wheel arch liner. Detach both track rod ends and bottom ball joints from the front hub assemblies, remove the anti-roll bar links from the struts, remove the drive shaft nuts and release the drive shafts from the hubs. Support the front sub frame with a transmission jack (See below), remove the six retaining bolts and gently lower the sub frame with the steering rack still attached.

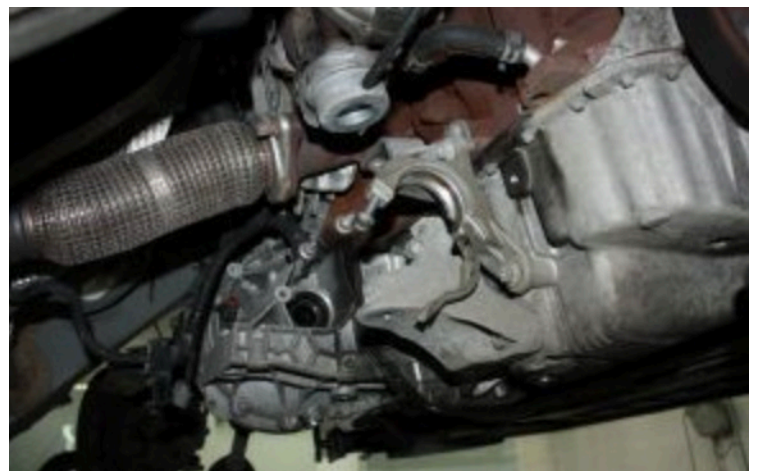
Now remove the starter motor and the gearbox drain plug and drain the gearbox oil. Once the oil has drained, refit and torque the drain plug, before removing both drive shafts. You should also release the intermediate bearing holder on the right drive shaft.

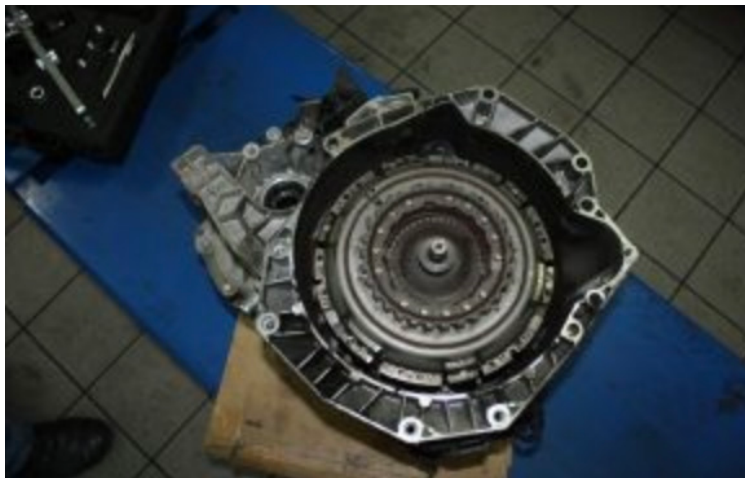
Remove the bell housing bolts, leaving two to support the gearbox that can easily be removed when the engine and gearbox are supported, then support the engine and gearbox, remove the gearbox mountings and lower the gearbox to a position that it is ready to be removed. Now remove the final two bell housing bolts and ease the gearbox out (note: the gearbox will be heavy as the double clutch is retained on the gearbox and not on the engine). With the gearbox removed we're now in a position to replace the clutch.

LuK trained and certified technicians can replace the double clutch assembly and engagement mechanism. Release the transport locks and adjust the clutch with the LuK special tools 400 0418 10 and 400 0423 10. Check the DMF anti-back lash ring for damage; our customer requested that we change the dual DMF whilst the gearbox was removed.
