LuK: 2010 Suzuki Alto K10 Engine

Clutch replacement in a 2010 Suzuki Alto, fitted with a 1.0L, three-cylinder K10B engine, which has covered more than 70,000 miles. The customer reported clutch slip, which was confirmed by a short road test, and clutch replacement was advised.

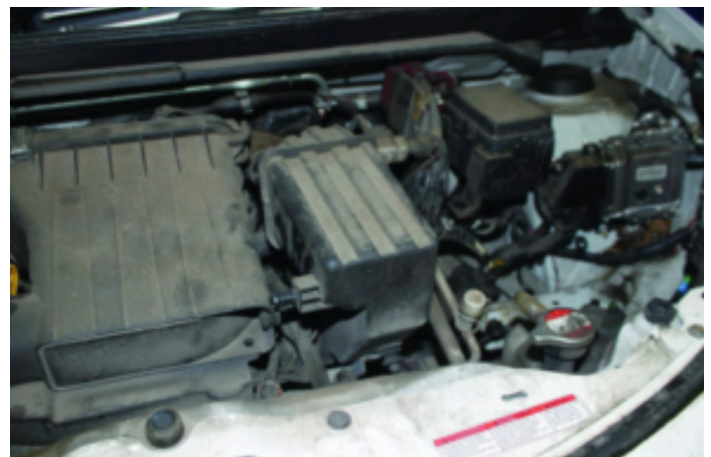
With the car placed on the ramp, starting in the engine bay, disconnect and remove the battery, battery case and battery carrier. The wiring loom retaining clips need to be unclipped from the battery carrier when removing. Now remove the air box/induction noise damper (see below) allowing more access to the gearbox and bell housing area. Slacken the clutch cable and then remove the cable from the clutch release arm, open the plastic retaining clip to release the cable and then slide the outer cable away from the support bracket (light lubrication may help the rubber slide out of the bracket) and stow in the bulkhead area. Remove the clutch cable support bracket as this gives a little extra room.

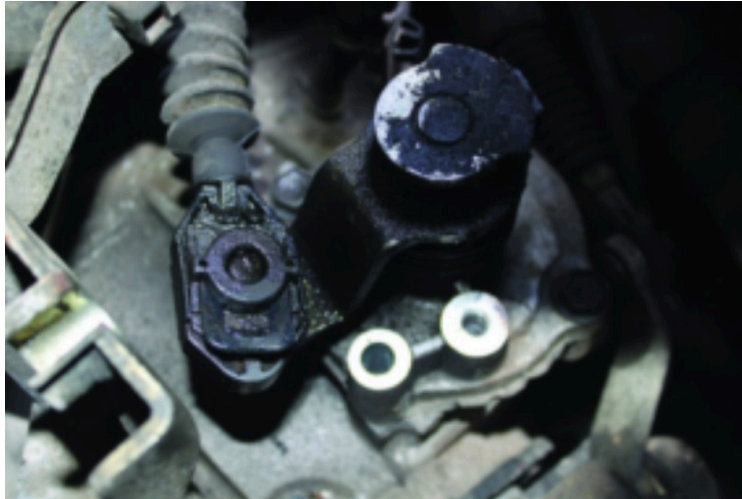
Disconnect the reverse light switch multiplug and stow the loom in the inner wing. Disconnect the gear change cables from the selector mechanism by removing the 'U clip' from the front cable (see below) and then detaching from the ball pivot. Disconnect the rear cable by removing the bolts from the pivot point bracket and removing the assembly (note – there is a small nylon bush located in this assembly that can fall out). Slide the outer cables upwards and out of their support bracket and stow in the bulkhead area, then disconnect the gearbox earth wire and bracket.

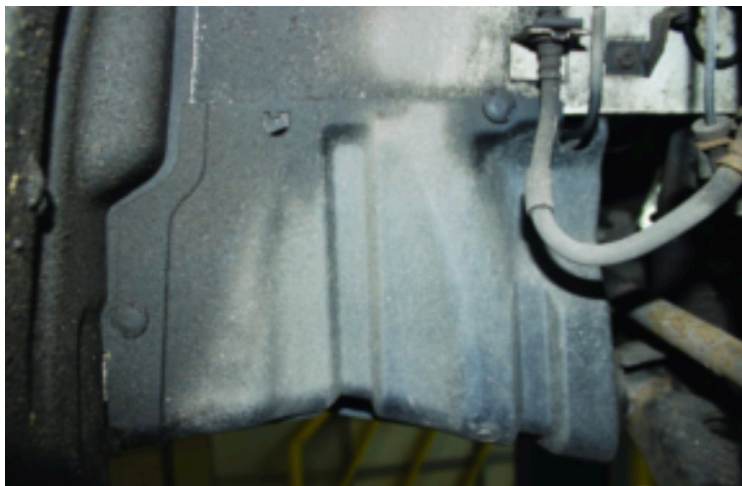
Now remove the upper bell housing bolts whilst the vehicle is on the ground and the bolts are easily accessible, storing in order and location. Next, slacken both driveshaft hub nuts and raise the vehicle to waist height. Remove both front wheels and hub nuts and the plastic shield in the N/S/F wheel arch area (see below), raise the vehicle to access the underside, drain the gearbox oil and then remove the locking pins from both bottom ball joint nuts and then take out the nuts and release both bottom ball joints. Both driveshafts can then be released from the respective hubs.

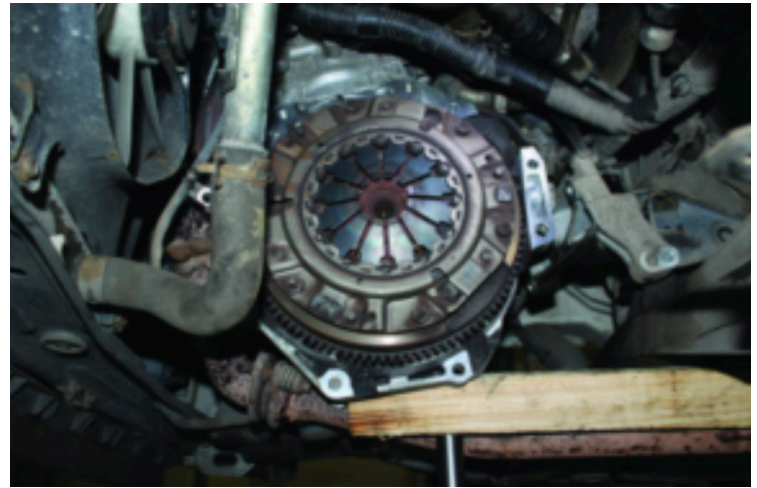
With the gearbox gone (see below), the clutch can be removed from the flywheel and, as suspected, the clutch had been worn out. This vehicle is fitted with a solid flywheel, so inspect for any damage or heat cracks, confirm the flywheel is serviceable and remove the glaze from the flywheel face with some Emory cloth and clean the flywheel area with some clutch and brake dust cleaner. Finally, remove the release bearing from the release arm in the bell housing.

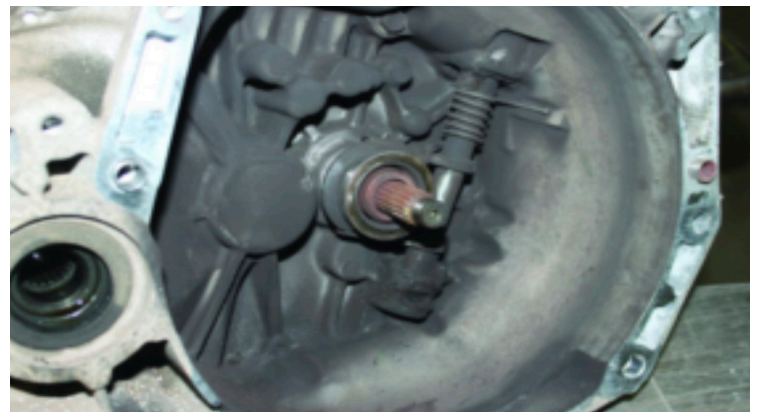
At this point we noticed that the release fork/arm had restricted movement due to the build-up of clutch dust at the pivot points and would not return to its rest position (see below), so we cleaned out the area with clutch and brake dust cleaner, and inspected the release system for any wear and carried out a check for correct and full operation

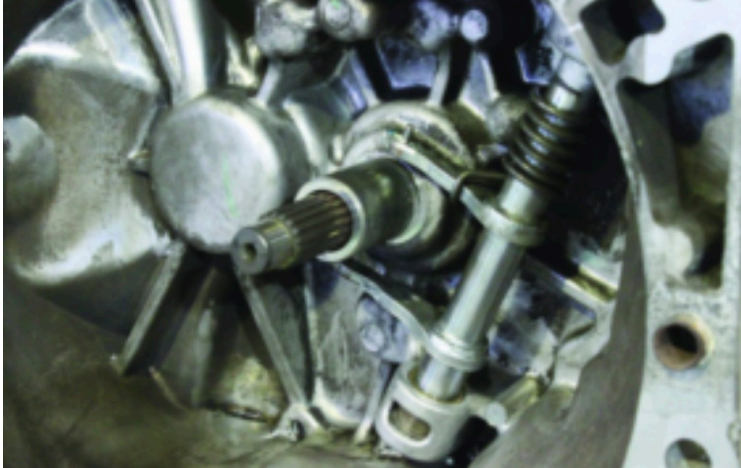
Fit the new release bearing, applying a very small amount of high melting point grease to the pivot areas as these are all metal. Apply a small amount of high melting point grease to the gearbox input shaft splines, then mount the clutch plate, confirming its correct position, and remove the clutch plate, wiping off any excess grease. Now mount the new clutch assembly onto the flywheel (see below) using a clutch alignment tool, ensuring the clutch plate is installed correctly so that the 'Gearbox side', or 'Getriebe Seite', markings on the clutch plate are facing the gearbox, tightening and torquing the bolts evenly and sequentially.
