## Exhausts & Emissions: Diagnosing a Failed Lambda Sensor

First fitted to passenger cars in the 1970s to improve the engine's combustion efficiency and reduce exhaust emissions, the lambda sensor is now a key component within the engine management system. But what are the visual symptoms of failure?

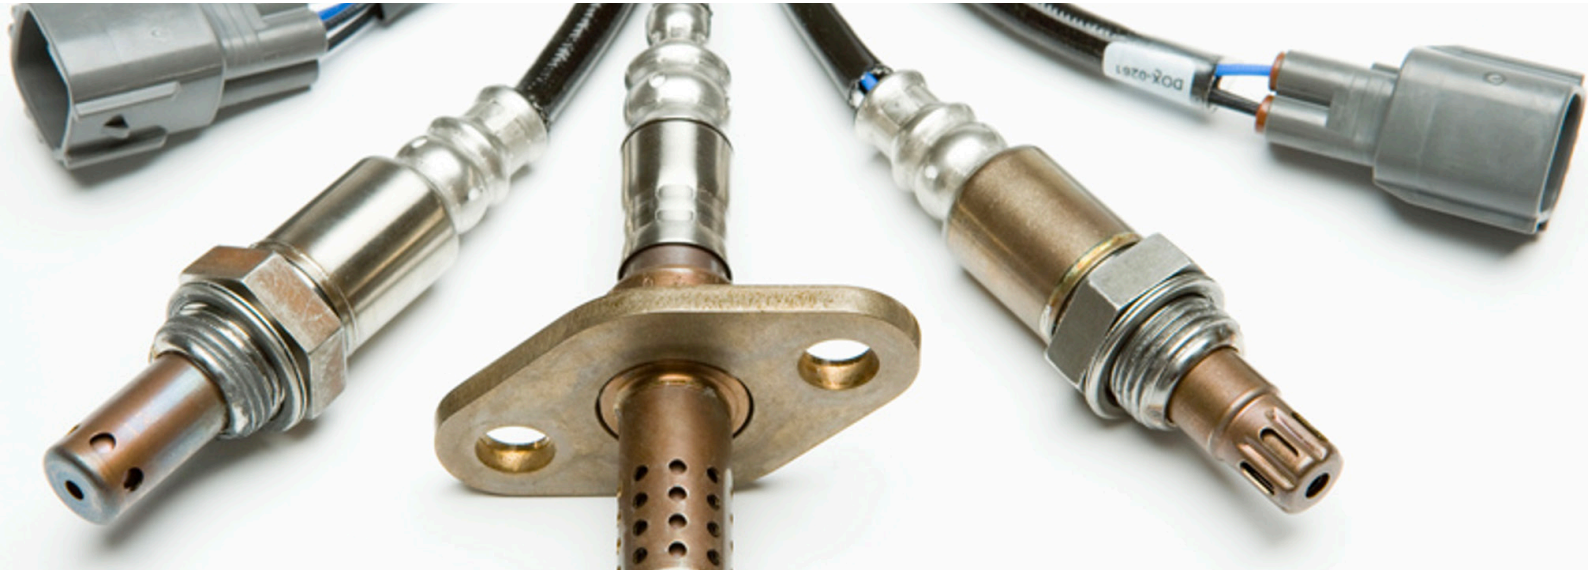
In order to operate efficiently, an internal combustion engine requires the correct ratio of air and fuel in its cylinders during the combustion process, with the ideal – known as lambda – being 14.7 parts air to one part fuel for a petrol engine and 14.5:1 for a diesel. Lambda sensors operate by measuring the amount of oxygen in the exhaust, to allow the engine management system to make the necessary adjustments to remain as close as possible to the ideal ratio.

These measurements have now become so precise that many vehicles feature several lambda sensors situated in the exhaust system, both before and after the catalytic converter. As global emissions standards have become ever more stringent, the variety and complexity of lambda sensors has increased accordingly and now includes zirconia, titanium, planar and wideband.
