Hella: VAUXHALL ASTRA - FUEL GAUGE FAULTY

Manufacturer: Opel/Vauxhall

Vehicle model: Astra K Engine: All models

Year of manufacture: 2015 - VIN: G8000000 - G8060668 Symptoms: Faulty fuel gauge

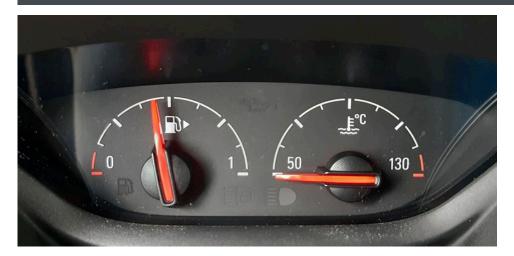
FUEL GAUGE DOES NOT DISPLAY THE CORRECT TANK CONTENT

On the vehicles mentioned above, the fuel level display on the instrument cluster may be displayed incorrectly, so it is possible that the tank is full but a lower fill level is displayed.

A 'software weakness' could be causing the problem.

To remedy the situation, check whether a software update is available for the vehicle. An Opel dealer should be contacted for this.
