Engine Parts & Timing Belts: VAG Belt Drive System

Vehicle make(s): Various, including Audi, SEAT, Skoda and VW models

Engine: 1.9 TDi 8V

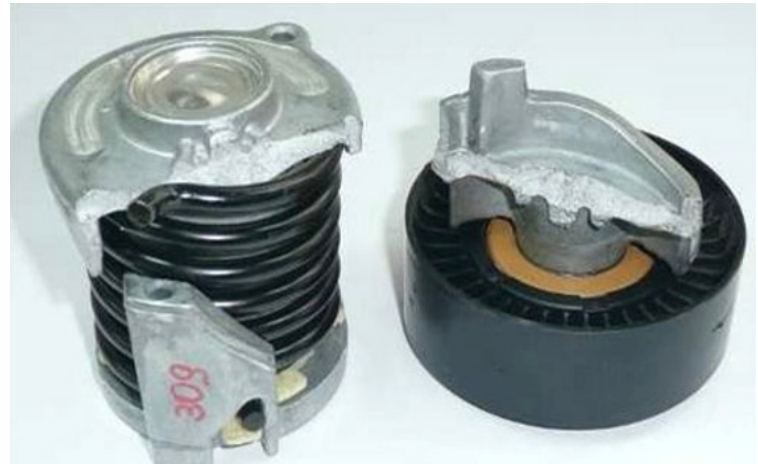
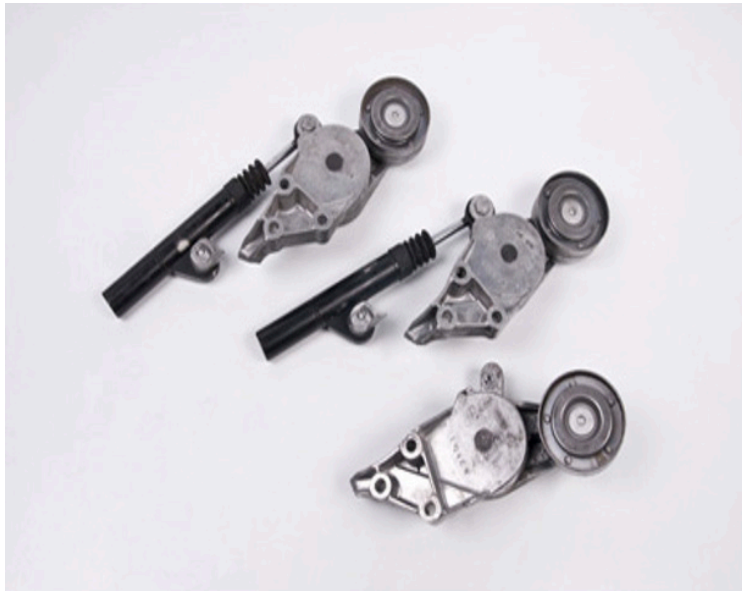
For example, an OAP that is underperforming generates vibrations that adversely affect the smooth running of the belt. The cumulative affect is to increase stress on the tensioner bracket, which begins to experience material fatigue. The ultimate consequence is the rupture of the tensioner bracket.

Analyses of examinations by Gates Inspectors on the aforementioned models show that rupture related to OAP wear will always take place at the same point: shearing takes place just above the connection of the tensioner bracket with the hydraulic damper. In such cases, shearing of the tensioner bracket is a symptom of the additional vibrations generated by the worn OAP and not the cause of the premature belt failure.

Unfamiliar with the components, mechanics often confuse the symptoms that are generated by wear of these components as problems with the belt. This is especially true in the wake of scheduled maintenance, where the OAP has not been considered for replacement at the same time as the belt.

Customers should be advised of the potential risks to the drive system if not replaced.
